Counties Manukau District Health Board  
Private Bag 93323  
Auckland 1640  
New Zealand

10 May 2019

### **Franklin Memorial Hospital - Intrusive Investigation Summary**

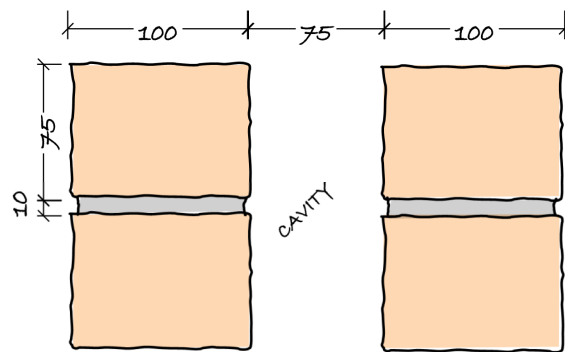
- Bricks – the bricks were measured as 210 mm long, 76 mm deep, and 100 mm wide. The bricks were noted as being 'hard' as they were unable to be scratched with a coin. The hardness of the brick, relative to the mortar is important as it can lead to a brittle failure mechanism.
- Mortar – the mortar joints were approximately 10 mm thick. The mortar did not scratch away easily when using a key, suggesting it is also 'hard'.

**Figure 1: Typical brick dimensions and cavity layout**

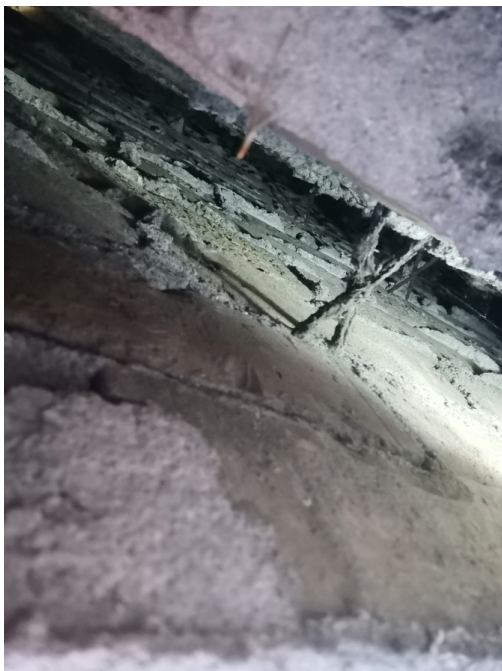
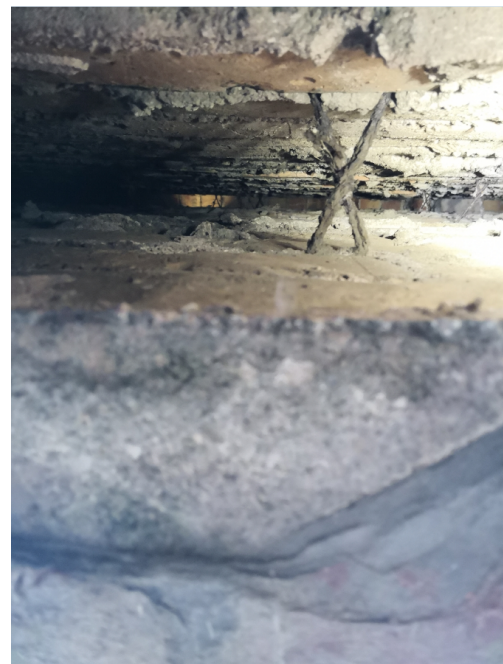
- Exterior Walls - the exterior walls are cavity brick construction. This consists of a single exterior veneer layer of bricks approx. 100 mm wide, a cavity 75 mm wide, then an internal brick layer. Beneath the floor level, the brick becomes solid to form a perimeter foundation wall. Cavity ties were observed to be at approximately 900 mm centres horizontally, and 1000 mm centres vertically. The ties appear as approximately an 8 gauge wire.

**Figure 2: Evidence of cavity ties in external walls**

The building has extensive use of unreinforced masonry (URM) load bearing internal single skin partitions and external cavity walls. Cavity ties were observed in the cavity walls, however the spacing and condition of these is inadequate to provide robust composite action between the two brick wythes. This suggests the external walls will act primarily as single skin walls. Single skin walls are particularly vulnerable to seismic shaking.

- The removal the brick chimneys,
- Installation of fixing anchors (Python or Helifix fixings) between the cavity brick walls to improve their seismic performance.
- Strapping of timber restraints to the tops of the walls. These will fix through to the brick and span between adjacent walls. This will change the behaviour of the walls from cantilevers to vertical spanning walls, improving their seismic performance.

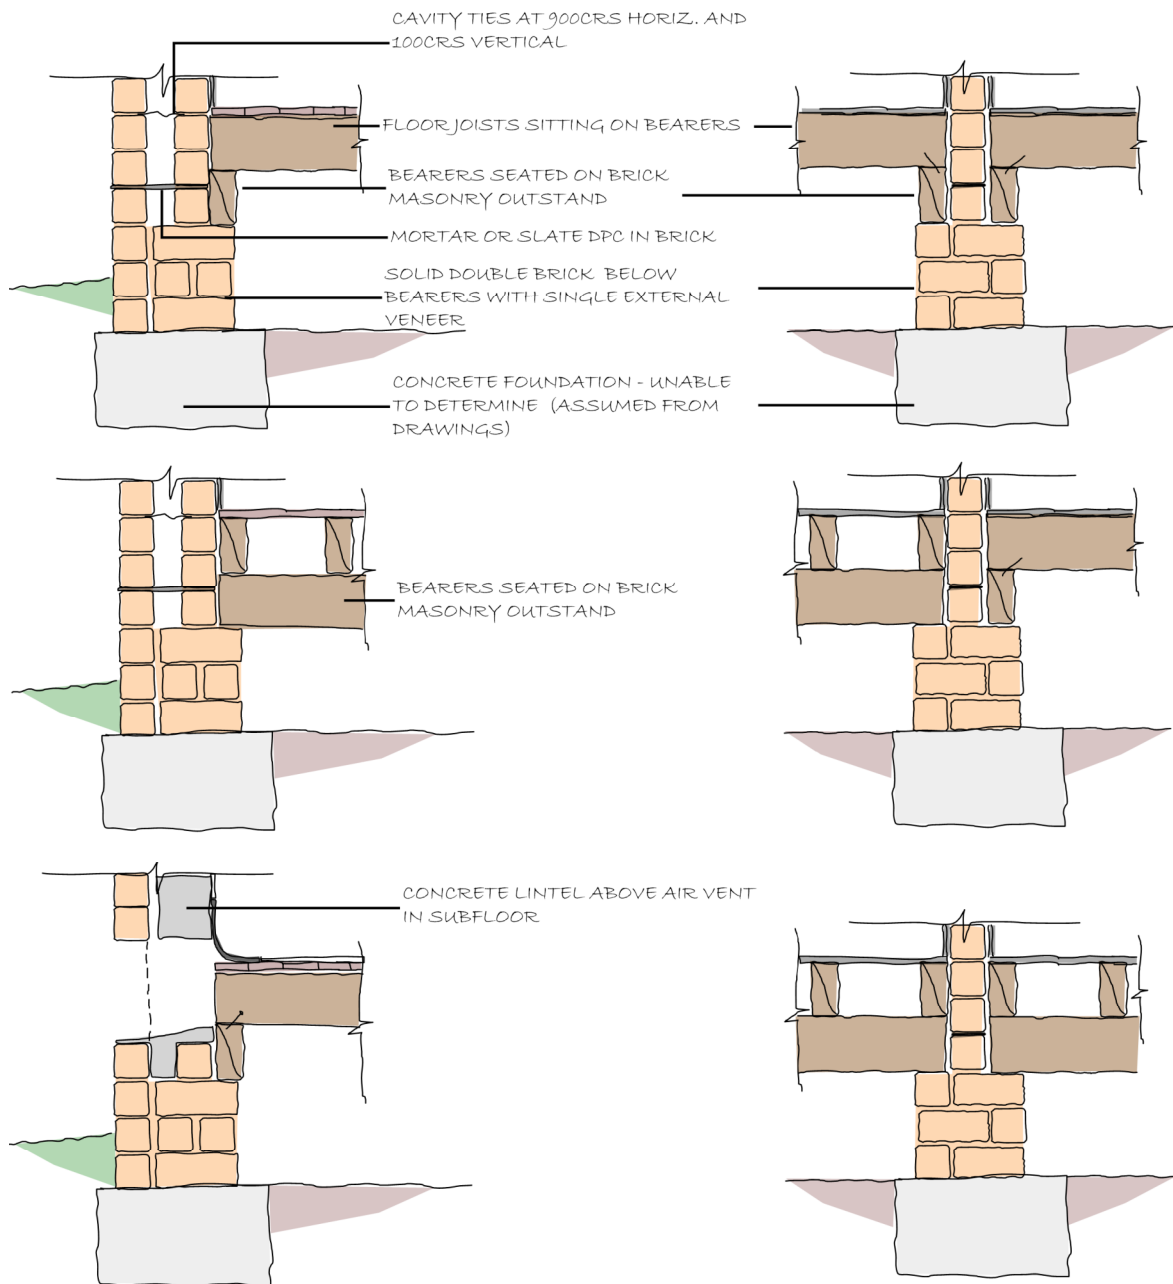
- Interior Walls – the interior walls are generally single brick with plaster linings directly fixed to the brick surface. In the northern area of the building where renovation works have been undertaken, timber stud walls have been constructed adjacent to the brick partition walls, but are unlikely to have a physical connection between the studs and the brick.

The connection to the top plate was unable to be observed.

**Figure 3: Typical construction details observed (top) typical cross section with joists transverse to exterior walls, (middle) joists parallel to walls (bottom) section through ventilation grate**

The walls are either cantilever or span vertically between the ceiling and the foundation, likely the former. This means the single layers of brick are particularly vulnerable to local failure, falling from height to form a potential life safety risk. The fact the walls are load bearing means there is a risk of local or global collapse of the roof structure due to failure of the walls, leading to a potential life safety risk for occupants.

- The removal of the brick chimneys
- New structural timber stud walls and lining to all external and internal URM wall. The studs will be fixed through to the brick walls to improve their seismic performance. The new timber studs will also have a top plate securing the top of the brick walls. This top plate will sit under the asbestos material, to avoid disturbing it, and span between adjacent perpendicular walls. Alternatively the internal single skin walls would be removed completely and replaced with timber framing.

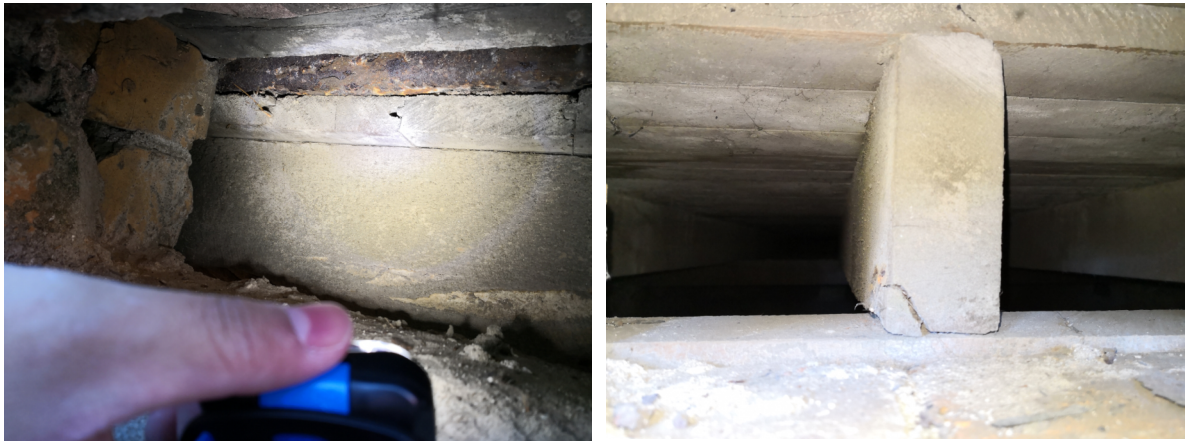
- Subfloor framing – the subfloor structure generally consists of 140 x 45 timber floor joists at 400 centres supporting 25 thick timber tongue-in-groove flooring. The joists are supported by bearers which span between small brick columns or between the brick foundation walls that continue through from above. There does not appear to be any direct connection (other than gravity support) between the floor and the brick walls, with the walls passing through the floor. No blocking between the timber joists was observed.

**Figure 4: Subfloor framing showing timber floor joists connected to timber bearers**

The floor structure is discontinuous through the internal walls, and the floor joists are not blocked at their ends. The lack of a connection to the floor means the walls are required to span down to the foundation level. This also means there is little likelihood of a distribution diaphragm to create a load path to stiffer foundation elements.

- New connection of the base of the walls to the floor structure through timber blocking bolted through brick.
- New blocking between floor joists and connection of the bearers to the brick substructure

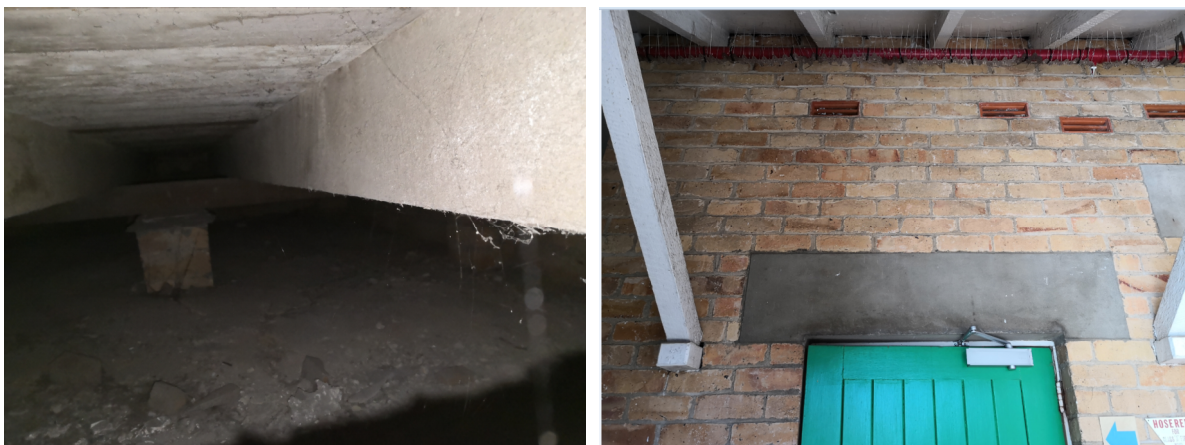
- Foundations – the timber bearers sit on brick jack piles. The connection of these was not evident beyond simple bearing on the top surface of the column.
- Lintels – the lintels above windows and doorways are concrete. It is unknown if these are reinforced.

**Figure 5: (left) Timber bearer sitting on solid brick column (right) concrete lintel above doorway**

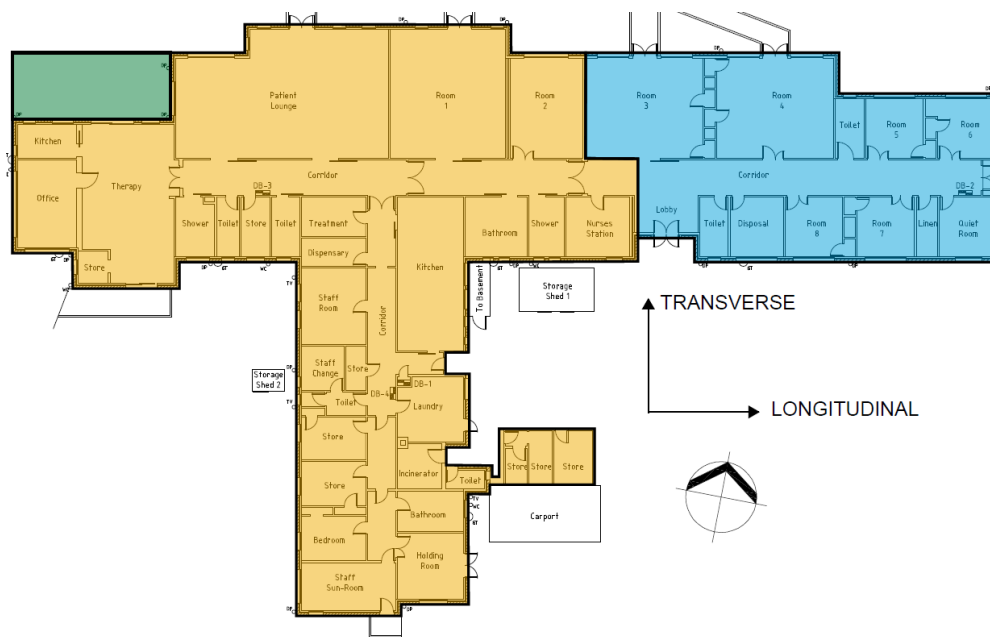
Note the area shown in yellow below is the original structure that has a number of potential critical structural weaknesses. The areas in blue and green are of modern construction (1980s) and are expected to perform adequately in an earthquake. Strengthening works are thus concentrated to the original area of the building.

**Figure 6: Plan of Franklin Memorial Hospital showing the various construction ages. The yellow section is the original building footprint**

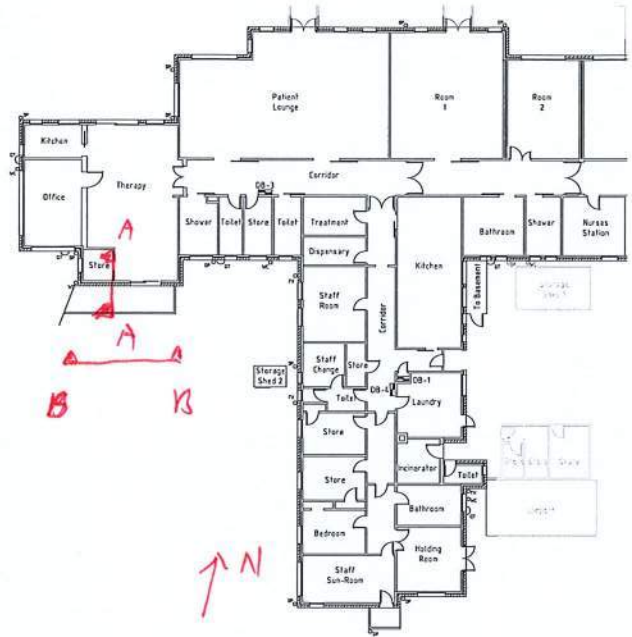
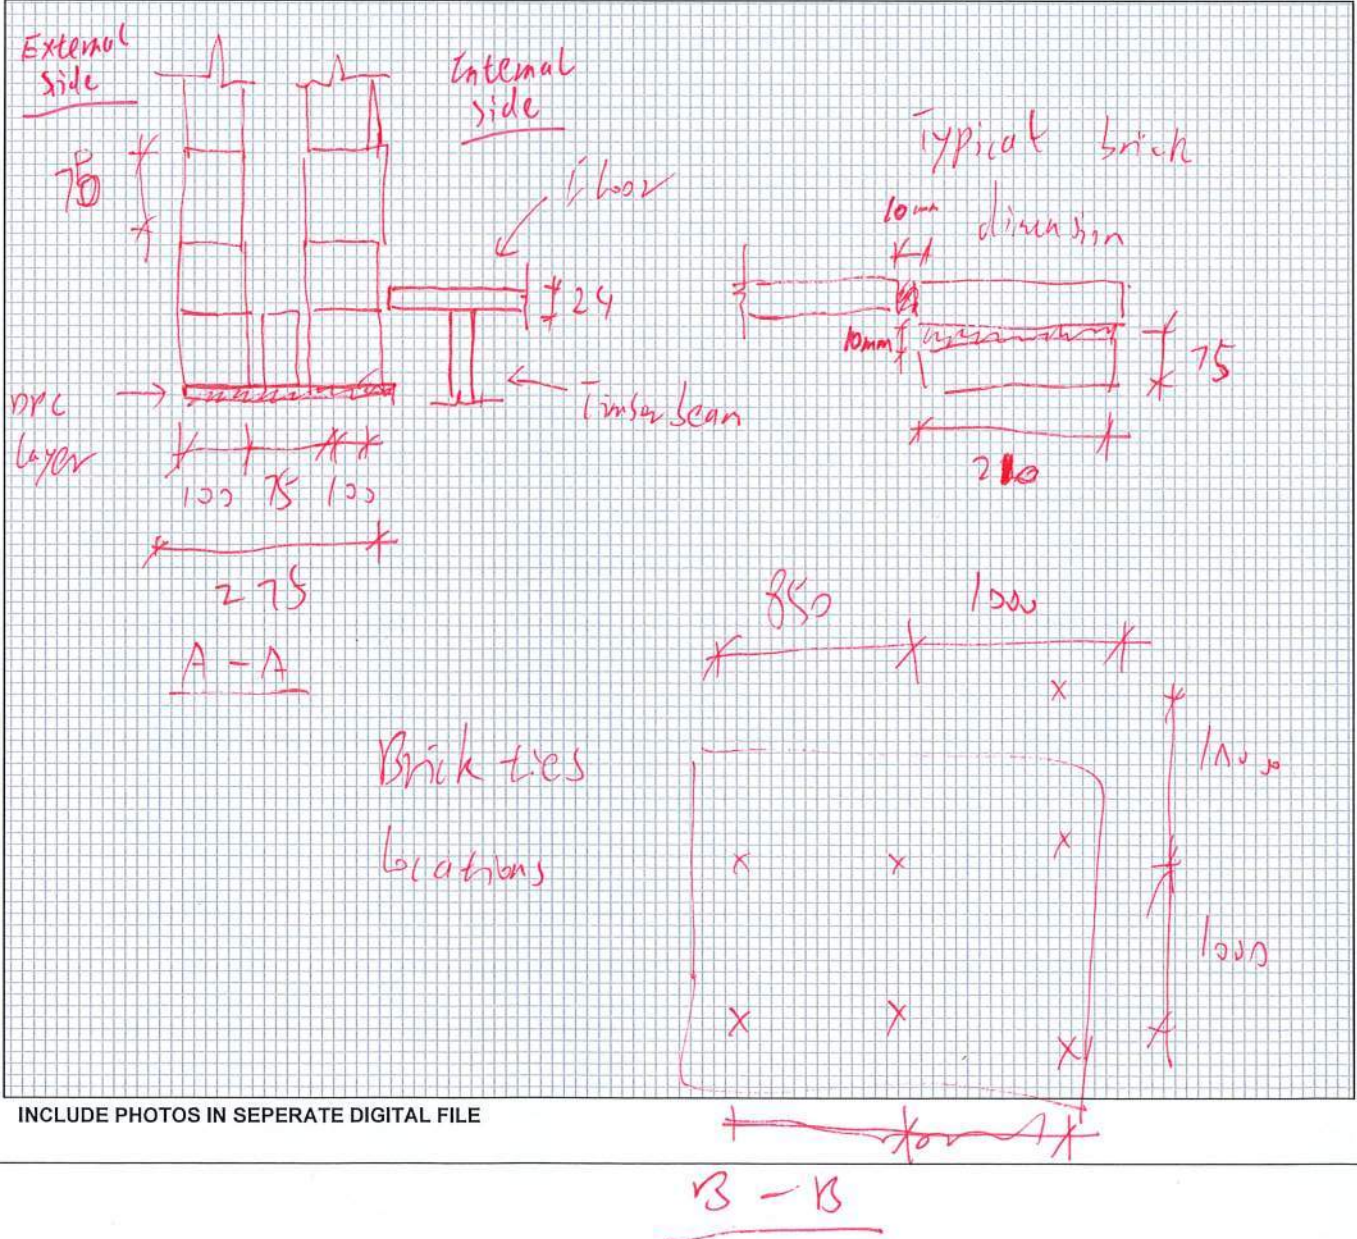
Section No.: Exterior Wall 1

Description/Comments: Exterior wall on southern side of building. Removed the ventilation net to observe cavity construction. Bricks with minor cracks.

- Very soft - raked out by finger pressure ☐
- Soft - scratches easily with fingernails ☐
- Medium - scratches with fingernails ☐
- Hard - Scratches with aluminium pick ☒
- Very Hard - Does not scratch with above tools ☐

- Soft - Scratches with aluminum pick ☐
- Medium - Scratches with 10 cent copper coin ☐
- Hard - Does not scratch with above tools ☒

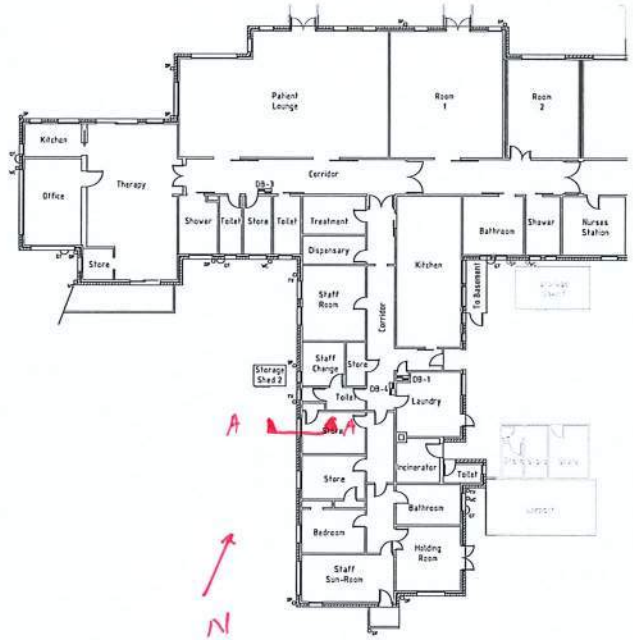
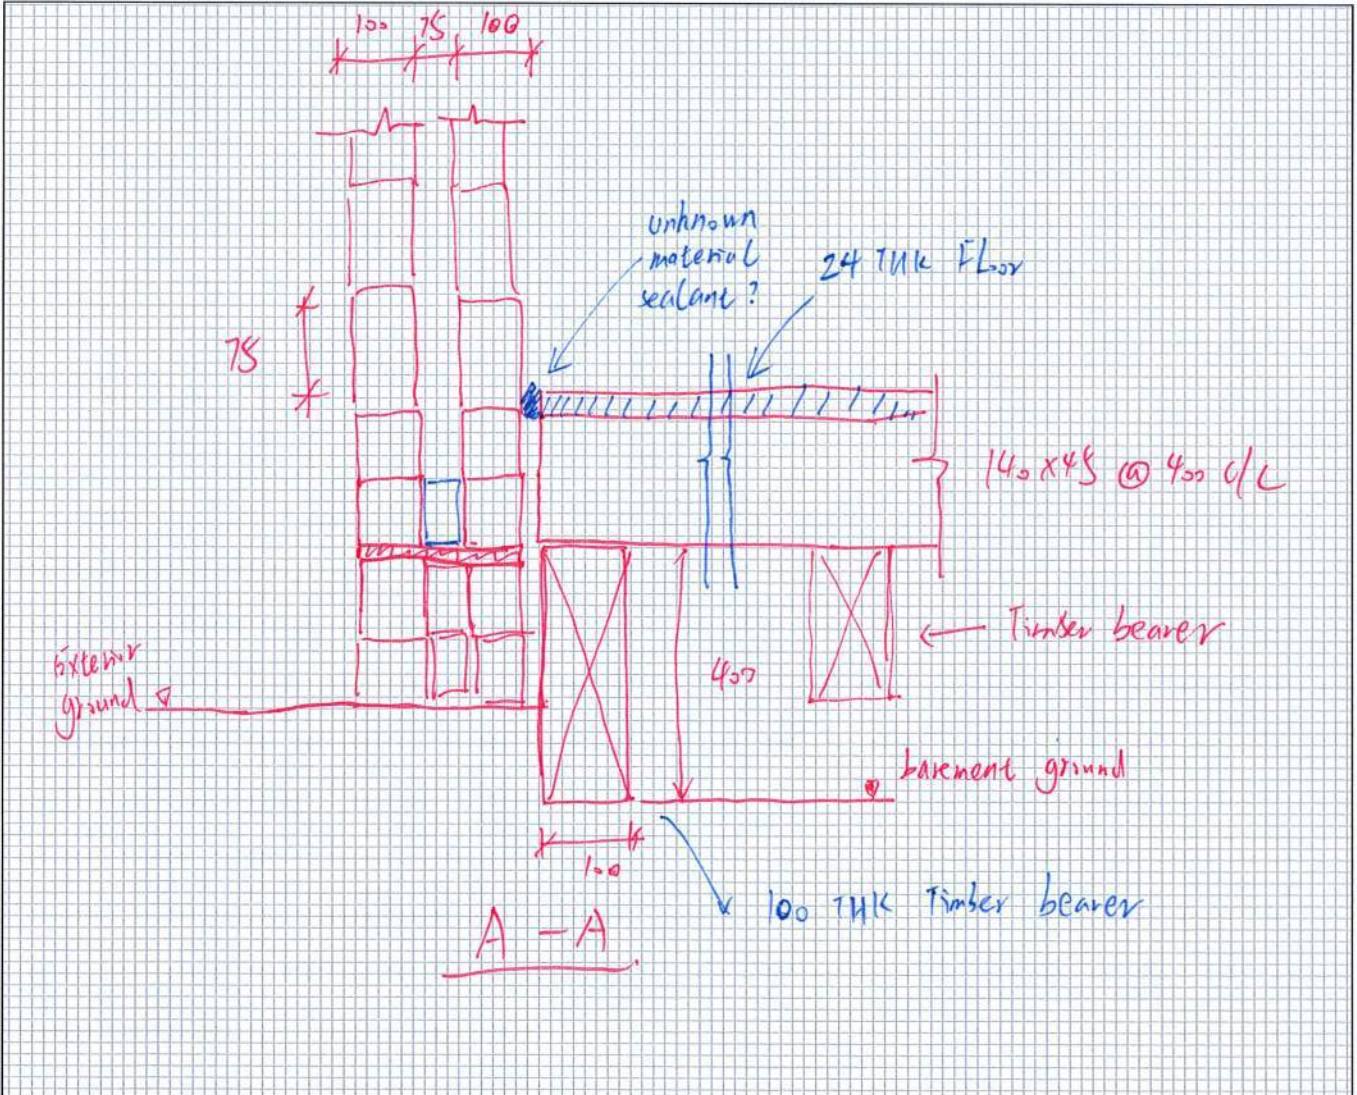
Section No.: *Exterior wall 2*  
 Description/Comments: *Exterior wall on western side of building.*

*Removed ventilation net to observe cavity construction.*

*Wall in good condition with minor cracks.  
 - Brick tie spacing similar to wall 1.*

Condition of mortar:	Very soft - raked out by finger pressure	<input type="checkbox"/>
	Soft - scratches easily with fingernails	<input type="checkbox"/>
	Medium - scratches with fingernails	<input type="checkbox"/>
	Hard - Scratches with aluminium pick	<input checked="" type="checkbox"/>
	Very Hard - Does not scratch with above tools	<input type="checkbox"/>
Condition of brick:	Soft - Scratches with aluminum pick	<input type="checkbox"/>
	Medium - Scratches with 10 cent copper coin	<input type="checkbox"/>
	Hard - Does not scratch with above tools	<input checked="" type="checkbox"/>

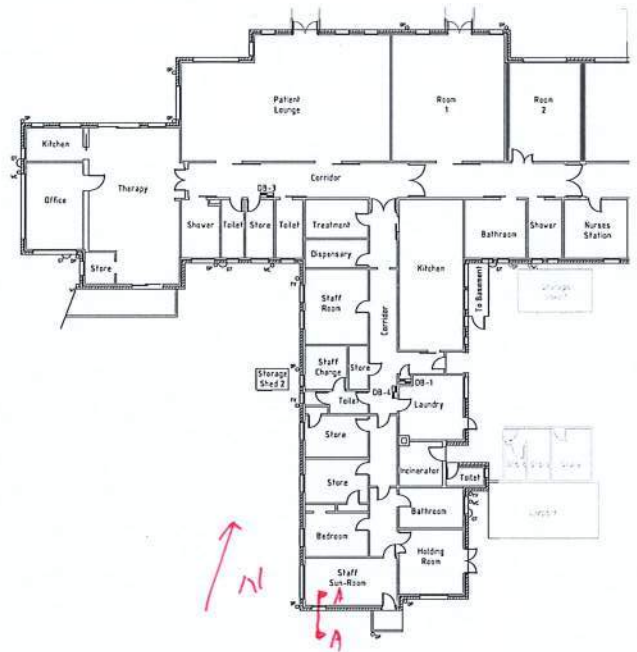
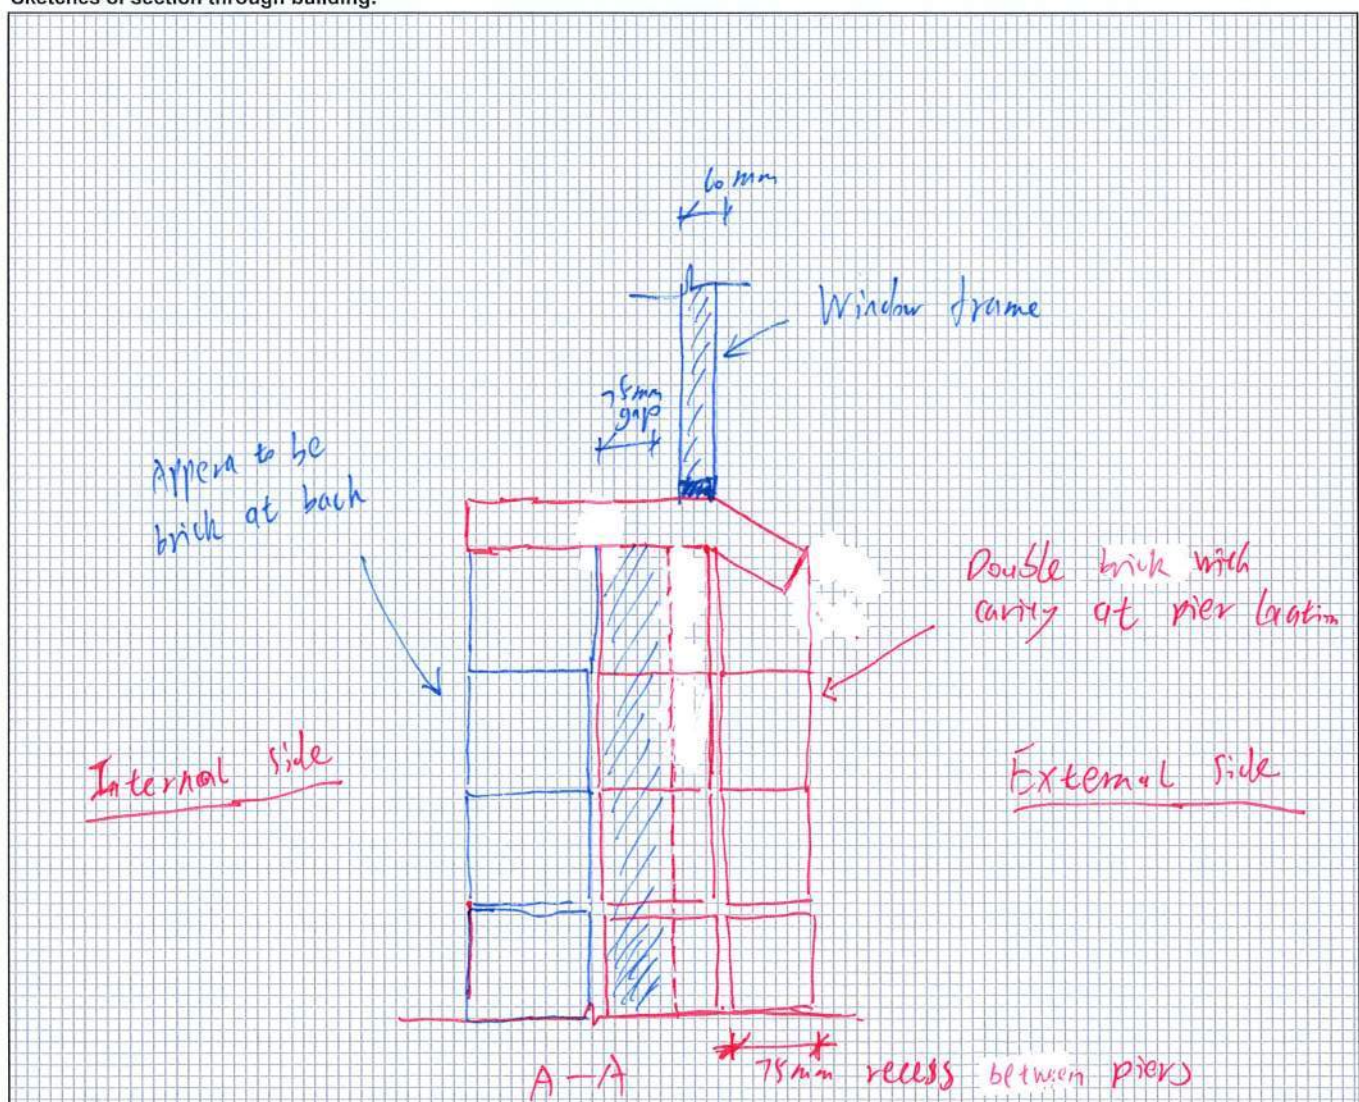
Section No.: *Exterior wall 3*

- New Mortar repair in late stage
- wall recess 75mm from exterior
- No brick to found on this wall
- Minor cracks on bricks

- Condition of mortar:
- Very soft - raked out by finger pressure ☐
  - Soft - scratches easily with fingernails ☐
  - Medium - scratches with fingernails ☐
  - Hard - Scratches with aluminium pick ☒
  - Very Hard - Does not scratch with above tools ☐
- Condition of brick:
- Soft - Scratches with aluminum pick ☐
  - Medium - Scratches with 10 cent copper coin ☐
  - Hard - Does not scratch with above tools ☒

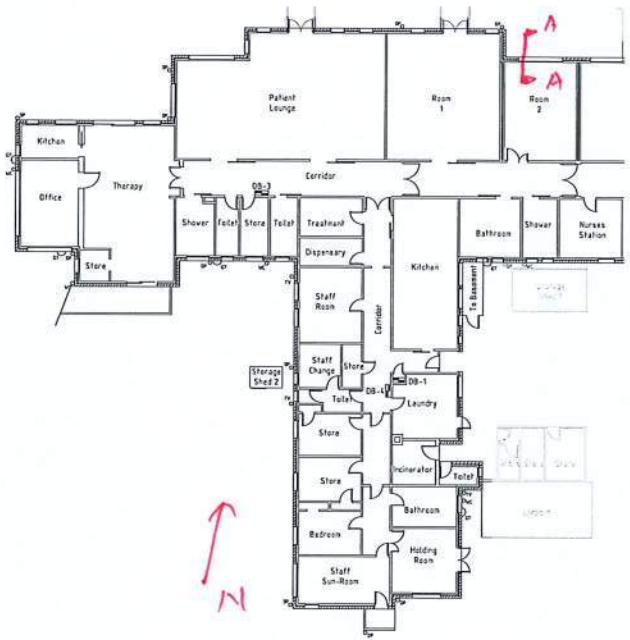
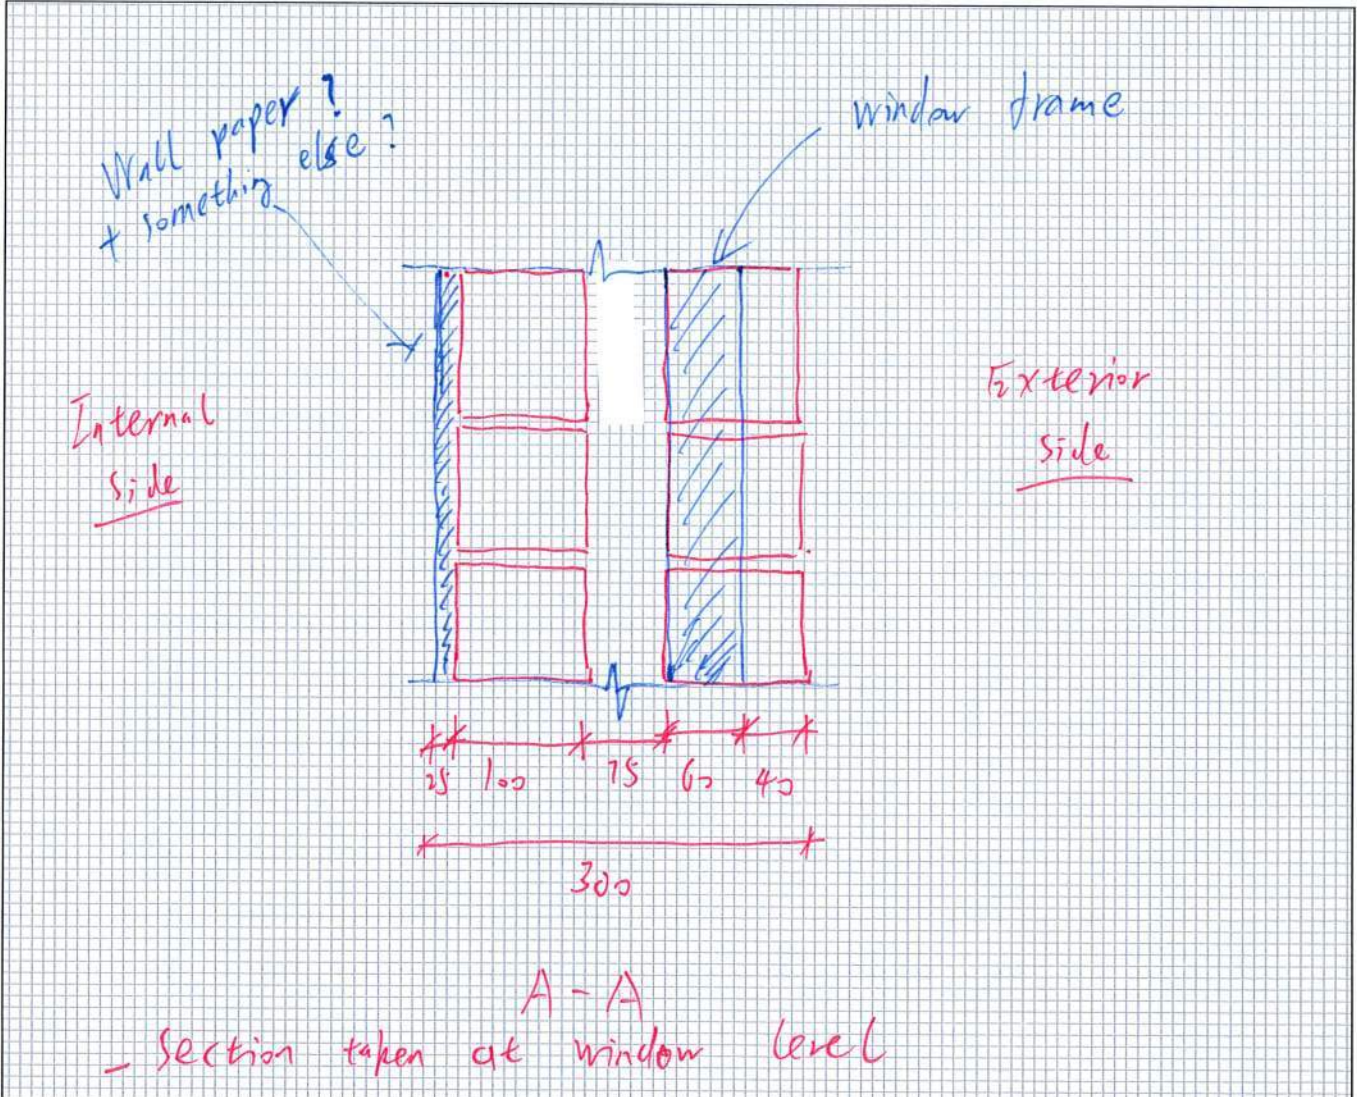
Section No.: Interior wall 2

Description/  
Comments: - No Jib wall inside

- Feel like wall paper
